TOST in Pictures

Part 2—Septic

Barry-Eaton District Health Department

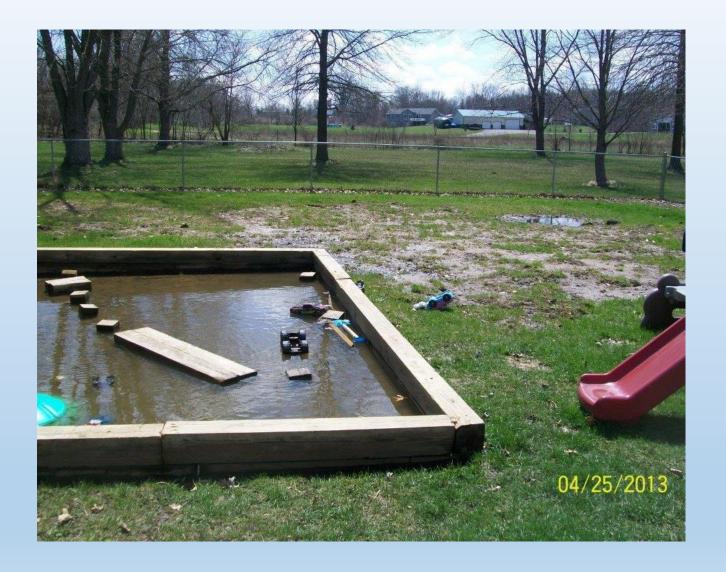
Sewage on ground surface

When a sewage system is in a state of failure, it usually becomes completely saturated (full of sewage and water). Untreated sewage can then migrate to the ground's surface. Wet weather conditions can help exacerbate this. You can see ponding sewage in this yard beyond the playset and sandbox.

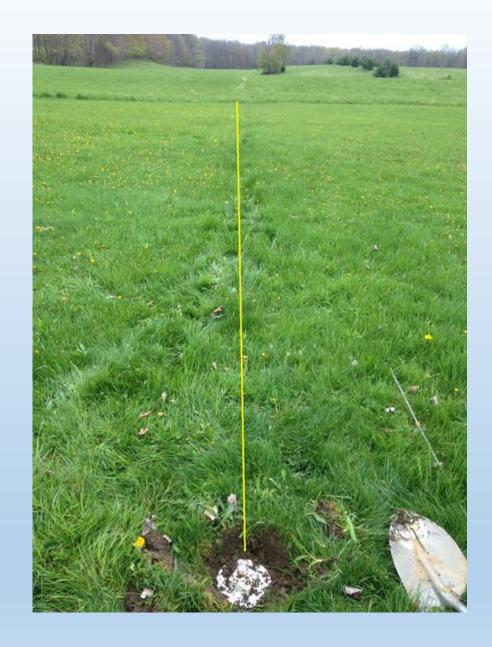
Sewage on ground surface

A plastic line was added to the end of a saturated drainfield, providing a route for sewage to travel to the ground's surface without being properly treated.

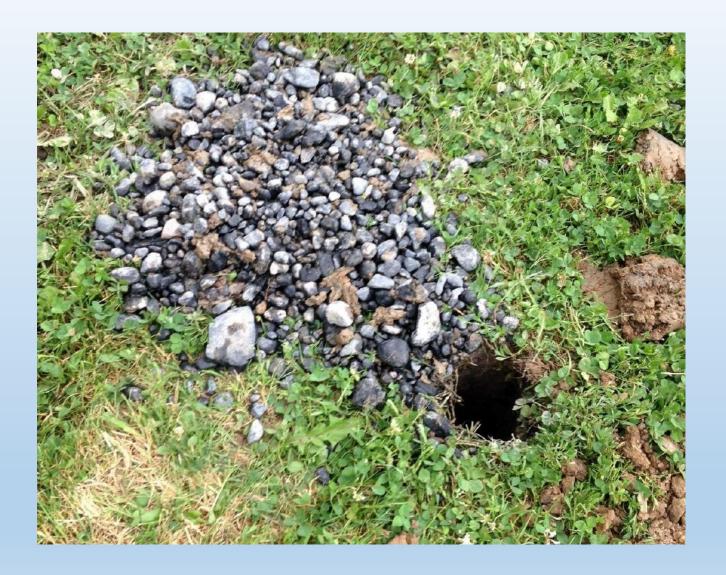
Black stone

When a drainfield is at the end of its working life, the stone in the drainfield becomes black and sludgy. This indicates that the system is not keeping up with the household water usage.

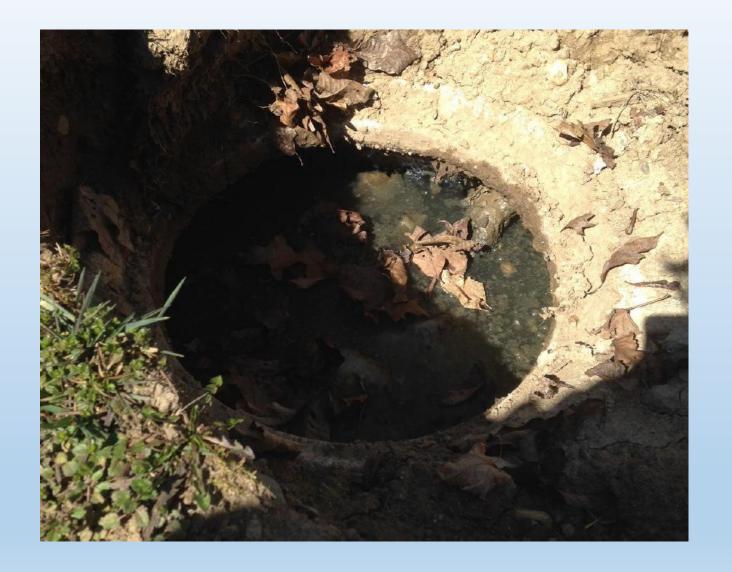
High septic tank water level

When a drainbed is completely saturated, the water has no place to go and can flow back into the septic tank. Here, the liquid level in the septic tank was almost up to the lid of the tank.

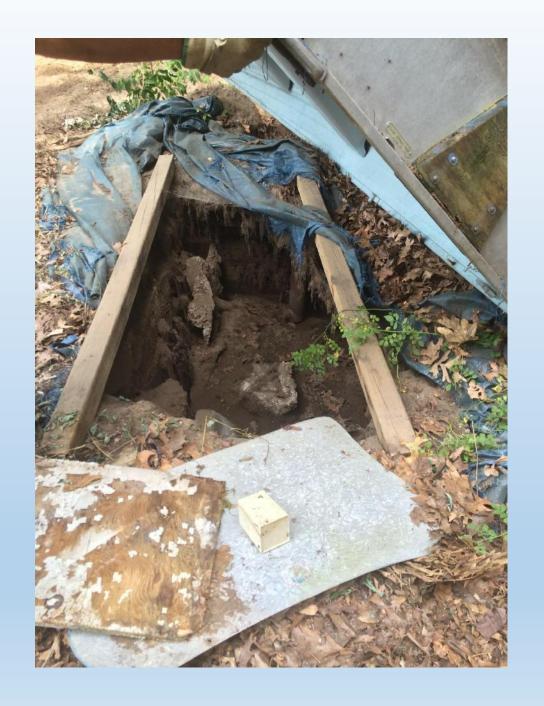
Septic tank collapse

The top of this septic tank collapsed, leading to an open pit filled with raw sewage. The bottom of a septic tank is normally four to six feet below the ground's surface. Humans and animals can fall into collapsed septic tanks and be seriously injured.

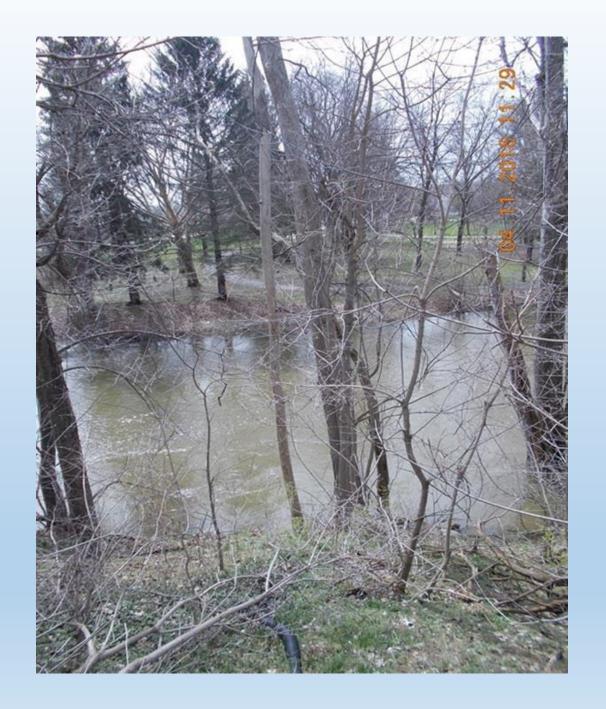
Waterway contamination

The black pipe located at the bottom of this picture led directly from the septic tank to the bank of the Thornapple River
